**Flood Control Project Maintenance  
Levee Inspections**  
**LMA District Cover Sheet**  
**Spring 2017 Levee Inspection Results**

**Yolo County Department of Natural Resources**

**Spring 2017 Levee Inspection Results**

**Levee Inspection Report By Mile - Spring 2017**

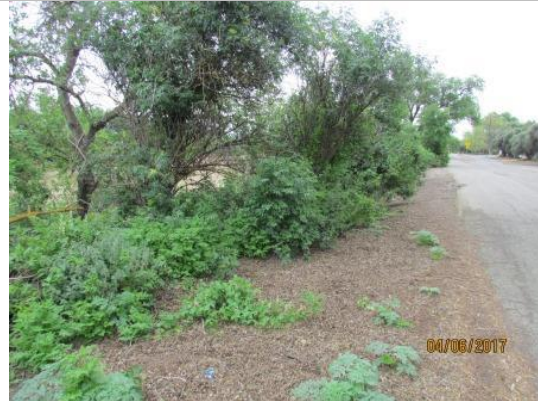
Photo 1 of 1 : SP\_2017\_NA0021\_351\_23\_20170413\_00031.jpg

LM Start	0.03	Rating **	U	Issue No.	23
LM End	0.13	Issue Type +	Ma	Location *	WS
Category	Earthen Levee			GPS Latitude/Longitude	
				Start	End
Item	Vegetation			38.720892 °	38.721233 °
				-121.810421 °	-121.808622 °
DWR ID	DWR_NA0021_01_s_2017_23				
Comment Code					
V2 : Remove the wild growth other than native grasses from the levee slopes.					
Inspector Comment

Wild vegetation on waterside levee slope, blocking visibility. Spring 2017.

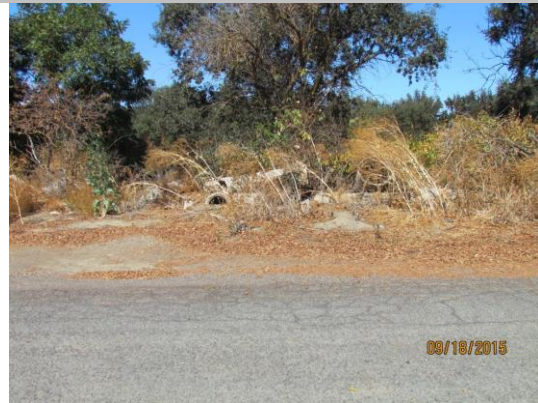
Photo 1 of 1 : SP\_2017\_NA0021\_351\_15\_20170320\_00015.jpg

LM Start	0.03	Rating **	M	Issue No.	15
LM End	0.03	Issue Type +	Ma	Location *	WS
Category	Earthen Levee			GPS Latitude/Longitude	
				Start	End
Item	Encroachments			38.720895 °	38.720895 °
				-121.810408 °	-121.810408 °
DWR ID	DWR_NA0021_01_f_2015_15				
Comment Code					
DE : Debris					
Inspector Comment

View of the debris on the waterward side of the levee. Fall 2015.

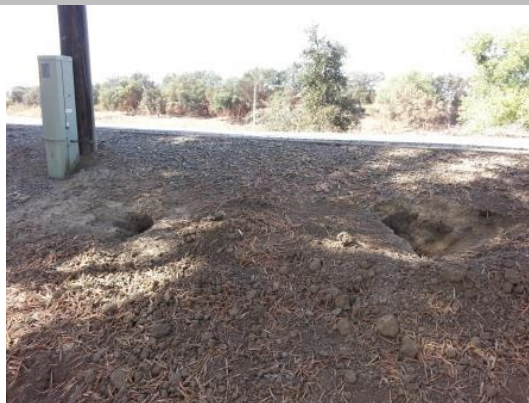
Photo 1 of 3 : SP\_2017\_NA0021\_351\_16\_20170320\_00016.jpg

LM Start	0.19	Rating **	U	Issue No.	16
LM End	0.19	Issue Type +	Ma	Location *	LS
Category	Earthen Levee			GPS Latitude/Longitude	
				Start	End
Item	Animal Control			38.721536 °	38.721536 °
				-121.807711 °	-121.807711 °
DWR ID	DWR_NA0021_01_s_2015_16				
Comment Code					
A3 : No rodents visible, but rodent burrows visible; need to backfill and compact or grout burrows.					
Inspector Comment

An updated view of rodent holes on LS slope. Fall inspection 10/07/2016.

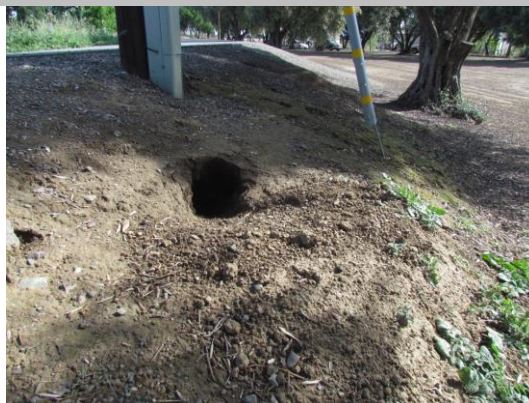
Photo 2 of 3 : SP\_2017\_NA0021\_351\_16\_20170320\_00017.jpg

View of the rodent hole on the landward side of the levee looking downstream. Spring 2015.

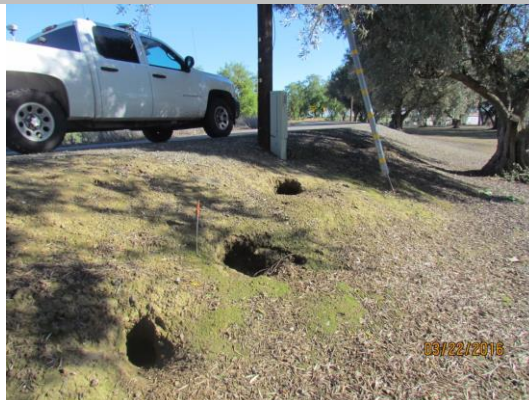
Photo 3 of 3 : SP\_2017\_NA0021\_351\_16\_20170320\_00018.jpg

View of the rodent holes on the landward side of the levee looking downstream. Spring 2016.

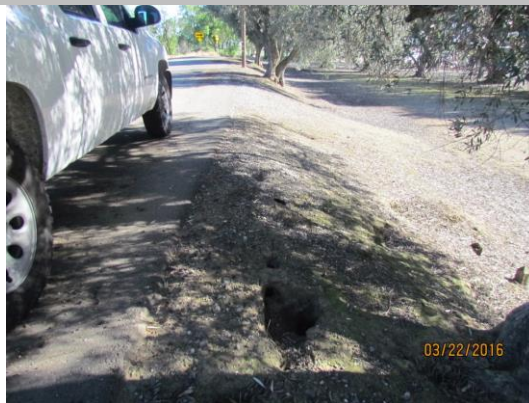
Photo 1 of 2 : SP\_2017\_NA0021\_351\_7\_20170320\_00007.jpg

LM Start	0.20	Rating **	M	Issue No.	7
LM End	0.20	Issue Type +	Ma	Location *	LS
Category	Earthen Levee			GPS Latitude/Longitude	
				Start	End
Item	Animal Control			38.721683 °	38.721683 °
				-121.807532 °	-121.807532 °
DWR ID	DWR_NA0021_01_s_2016_7				
Comment Code					
A3 : No rodents visible, but rodent burrows visible; need to backfill and compact or grout burrows.					
Inspector Comment

Perspective view of the rodent hole on the landward side of the levee looking downstream. Spring 2016.

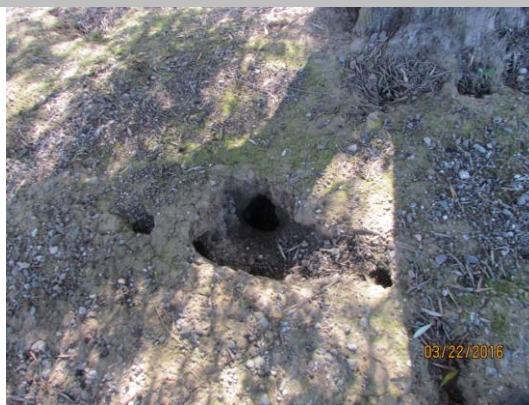
Photo 2 of 2 : SP\_2017\_NA0021\_351\_7\_20170320\_00008.jpg

Animal hole is close to the shoulder of the levee. Spring 2016.

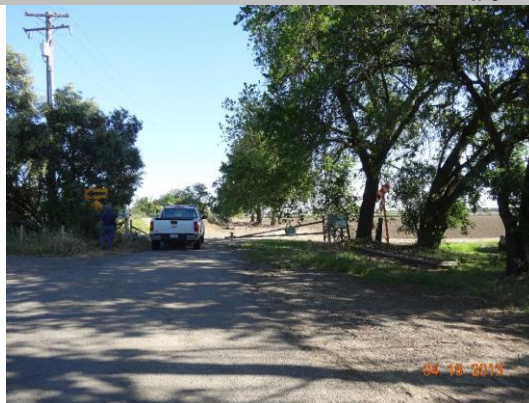
Photo 1 of 3 : UCIP\_SP\_2017\_39855\_69553.jpg

LM Start	0.24	Rating **	M	Issue No.	25
LM End	0.24	Issue Type +	En	Location *	LS
Category	Supplemental			GPS Latitude/Longitude	
				Start	End
Item	DWR UCIP Field Study			38.722162 °	38.722162 °
				-121.807223 °	-121.807223 °
DWR ID					
Comment Code					
Inspector Comment					
FS_ID:39855					
DS_ID:19554					
EP_NO: 6790					
Repair Type: Non-Urgent					
Crossing Status: Indicator Found					
UCIP Comments: Need to contact owner to determine if crossing is still active and to determine last inspection date. Will need copy of letter showing crossings passed inspection.					
FIELD_STRUCT_DESC: 6-inch gas line through levee, 4-feet below the crown. Pipe extends from borrow area and under the channel. Bleeder valve on waterward bank. Service vault located on landward side next to access gate. Paved access ramp on landward slope. (Permit No. 6790-1970)					
FS Date: 4/16/2013

View of landward side near access gate. Gas line marker located on between trees. Line runs parallel to access roadway and through levee.

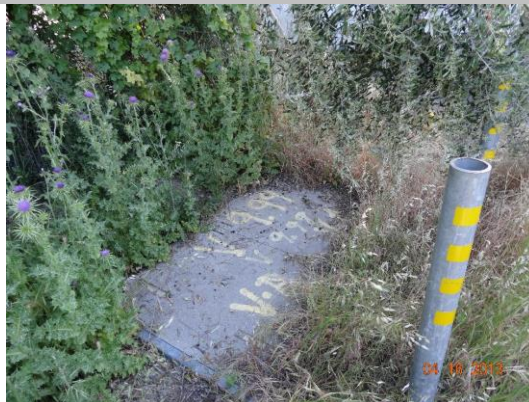
Photo 2 of 3 : UCIP\_SP\_2017\_39855\_69554.jpg

Service vault located on landward toe near gate access gate.

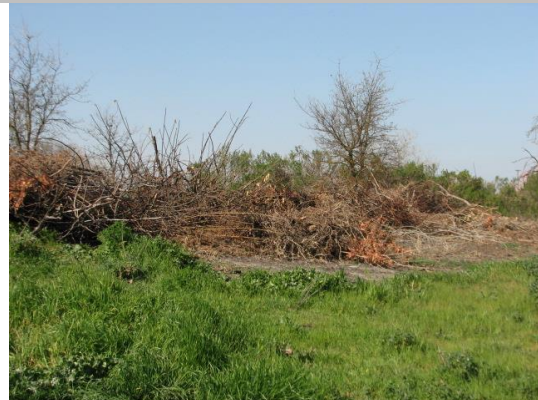
Photo 1 of 3 : SP\_2017\_NA0021\_351\_4\_20170320\_00003.jpg

LM Start	0.26	Rating **	M	Issue No.	4
LM End	0.26	Issue Type +	Ma	Location *	WS
Category	Earthen Levee			GPS Latitude/Longitude	
				Start	End
Item	Encroachments			38.722418 °	38.722418 °
				-121.806999 °	-121.806999 °
DWR ID	DWR_NA0021_01_s_2012_4				
Comment Code					
PR : Prunings					
Inspector Comment

A continuous brush pile on levee. Spring 2013

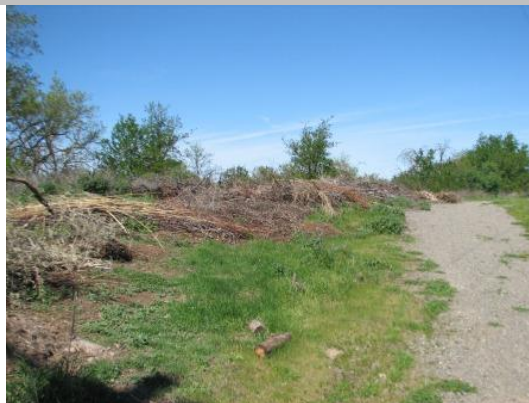
Photo 2 of 3 : SP\_2017\_NA0021\_351\_4\_20170320\_00004.jpg

The brush pile did not get burned this last winter. Spring 2014

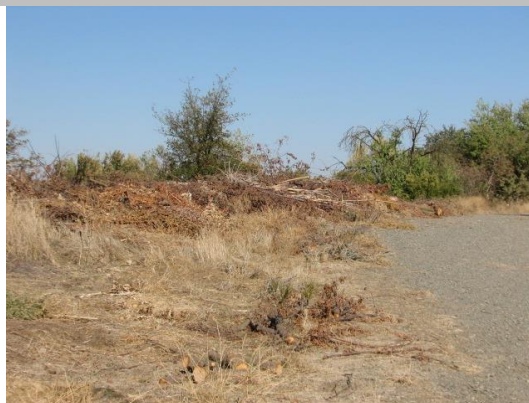
Photo 3 of 3 : SP\_2017\_NA0021\_351\_4\_20170320\_00005.jpg

The latest look of the ongoing brush pile. Fall 2013

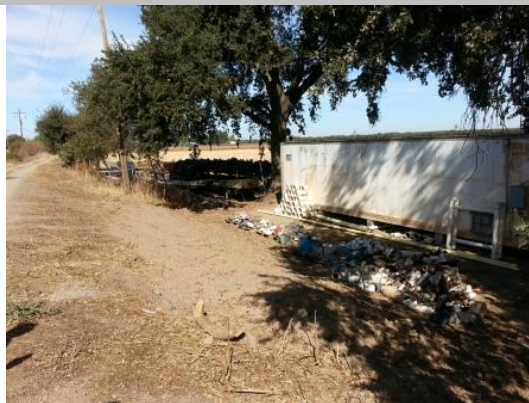
Photo 1 of 3 : SP\_2017\_NA0021\_351\_18\_20170320\_00020.jpg

LM Start	0.27	Rating **	M	Issue No.	18
LM End	0.27	Issue Type +	En	Location *	LS
Category	Earthen Levee			GPS Latitude/Longitude	
				Start	End
Item	Encroachments			38.722615 °	38.722615 °
				-121.806952 °	-121.806952 °
DWR ID	DWR_NA0021_01_s_2015_18				
Comment Code					
EQ : Equipment					
Inspector Comment

Updated picture of equipment near LS toe of the levee. Fall inspection 10/07/2016.

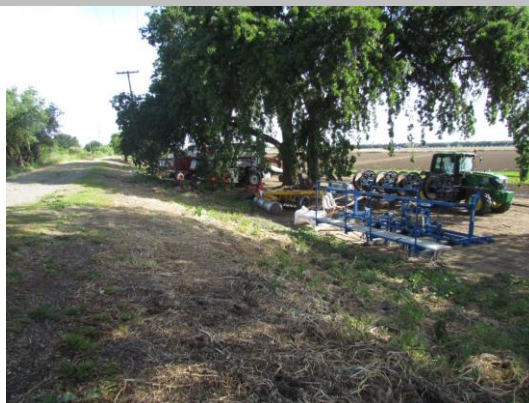
Photo 3 of 3 : SP\_2017\_NA0021\_351\_18\_20170320\_00022.jpg

View of equipment on the landward side of the levee looking downstream. Spring 2015.

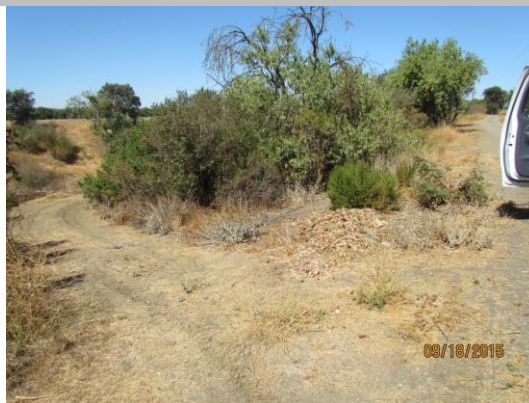
Photo 1 of 3 : SP\_2017\_NA0021\_351\_22\_20170320\_00025.jpg

LM Start	0.27	Rating **	M	Issue No.	22
LM End	0.27	Issue Type +	Ma	Location *	WS
Category	Earthen Levee			GPS Latitude/Longitude	
				Start	End
Item	Slope Stability			38.722620 °	38.722620 °
				-121.806958 °	-121.806958 °
DWR ID	DWR_NA0021_01_f_2015_22				
Comment Code					
S3 : Repair the levee slope damaged by vehicle traffic and prevent access where possible.					
Inspector Comment					
A vehicle ramp seems to have been made.

Perspective view of the trail on the waterward side of the levee looking downstream. Fall 2015.

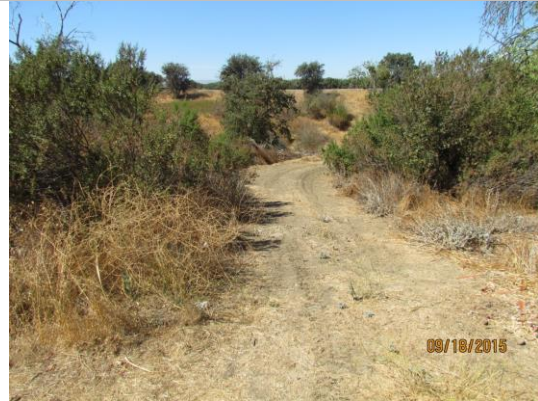
Photo 2 of 3 : SP\_2017\_NA0021\_351\_22\_20170320\_00026.jpg

View of the trail on the waterward side of the levee. Fall 2015.

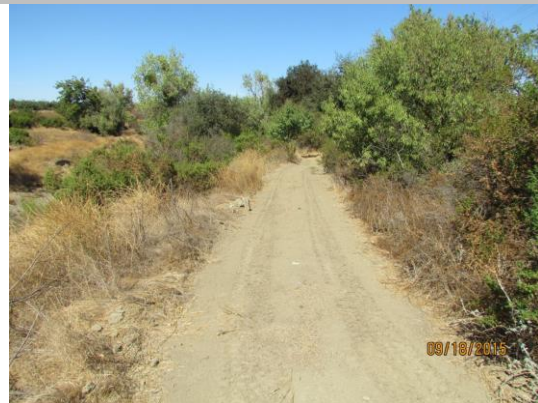
Photo 3 of 3 : SP\_2017\_NA0021\_351\_22\_20170320\_00027.jpg

The trail seems to be an access point that leads down to Cache Creek. Fall 2015.

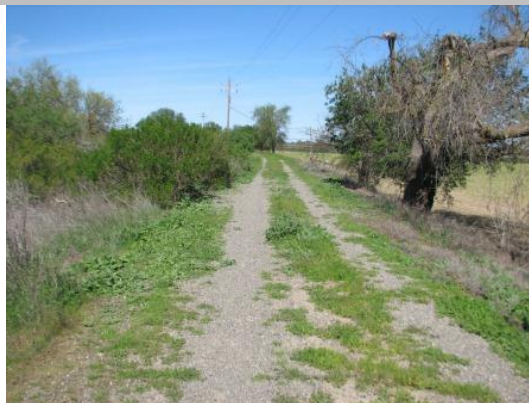
Photo 1 of 1 : SP\_2017\_NA0021\_351\_13\_20170320\_00014.jpg

LM Start	0.30	Rating **	M	Issue No.	13
LM End	0.50	Issue Type +	Ma	Location *	CR
Category	Earthen Levee			GPS Latitude/Longitude	
				Start	End
Item	Vegetation			38.723017 °	38.725844 °
				-121.806879 °	-121.806516 °
DWR ID	DWR_NA0021_01_s_2014_13				
Comment Code					
V9 : Keep the crown roadway free of vegetation.					
Inspector Comment

Vegetation on the crown needs to be controlled. Spring 2014

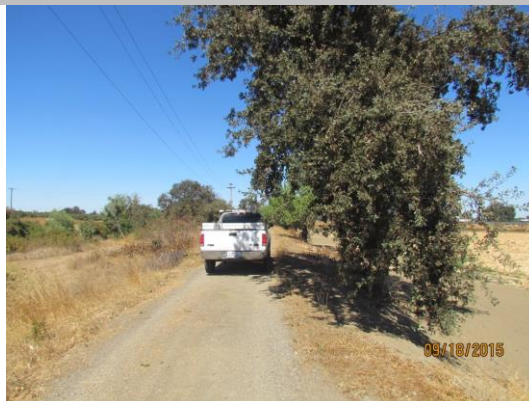
Photo 1 of 1 : SP\_2017\_NA0021\_351\_6\_20170320\_00006.jpg

LM Start	0.36	Rating **	M	Issue No.	6
LM End	0.36	Issue Type +	Ma	Location *	LS
Category	Earthen Levee			GPS Latitude/Longitude	
				Start	End
Item	Trim / Thin Trees			38.723903 °	38.723903 °
				-121.806613 °	-121.806613 °
DWR ID	DWR_NA0021_01_s_2012_6				
Comment Code					
T1 : Trim trees to at least five feet above ground level.					
Inspector Comment

View of the tree on the landward side of the levee looking downstream.  
Fall 2015.

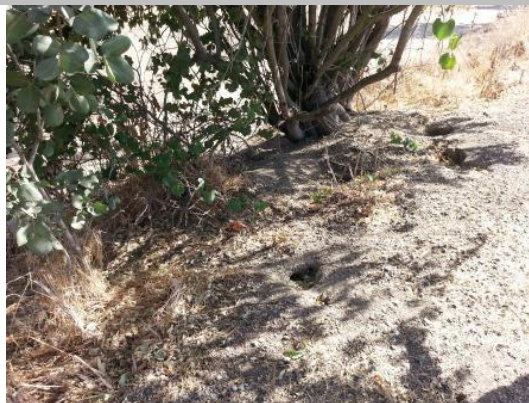
Photo 1 of 1 : SP\_2017\_NA0021\_351\_2\_20170320\_00001.jpg

LM Start	0.40	Rating **	M	Issue No.	2
LM End	0.40	Issue Type +	Ma	Location *	LS
Category	Earthen Levee			GPS Latitude/Longitude	
				Start	End
Item	Animal Control			38.724437 °	38.724437 °
				-121.806620 °	-121.806620 °
DWR ID	DWR_NA0021_01_f_2016_2				
Comment Code					
A3 : No rodents visible, but rodent burrows visible; need to backfill and compact or grout burrows.					
Inspector Comment

Rodent holes on LS slope. Fall inspection 10/07/2016.

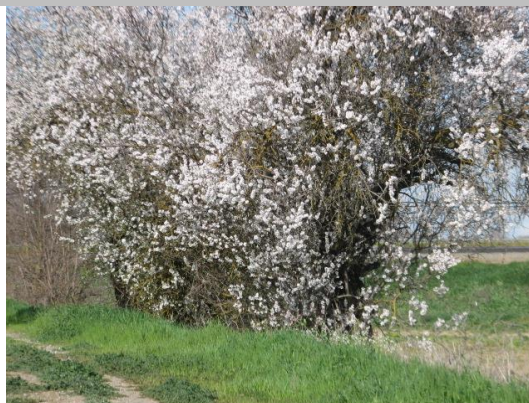
Photo 1 of 2 : SP\_2017\_NA0021\_351\_9\_20170320\_00010.jpg

LM Start	0.44	Rating **	M	Issue No.	9
LM End	0.44	Issue Type +	Ma	Location *	LS
Category	Earthen Levee			GPS Latitude/Longitude	
				Start	End
Item	Trim / Thin Trees			38.725022 °	38.725022 °
				-121.806478 °	-121.806478 °
DWR ID	DWR_NA0021_01_s_2012_9				
Comment Code					
T1 : Trim trees to at least five feet above ground level.					
Inspector Comment

Trees need to be trimmed to 5'. Spring 2013

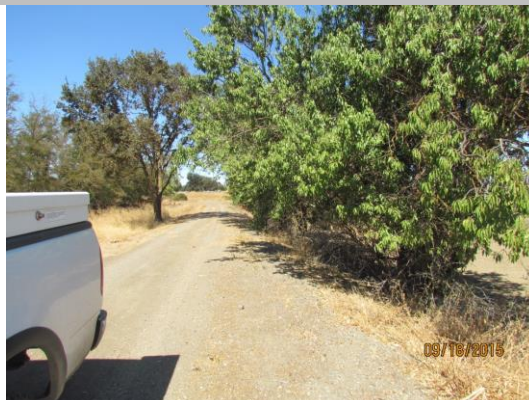
Photo 2 of 2 : SP\_2017\_NA0021\_351\_9\_20170320\_00011.jpg

View of the tree that needs to be trimmed on the landward side of the levee looking downstream. Fall 2015.

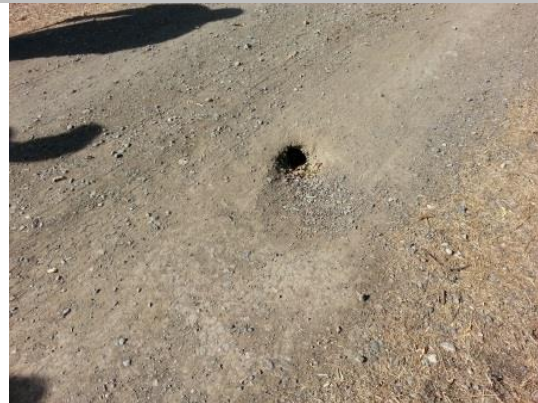
Photo 1 of 1 : SP\_2017\_NA0021\_351\_3\_20170320\_00002.jpg

LM Start	0.44	Rating **	M	Issue No.	3
LM End	0.44	Issue Type +	Ma	Location *	CR
Category	Earthen Levee			GPS Latitude/Longitude	
				Start	End
Item	Animal Control			38.725087 °	38.725087 °
				-121.806502 °	-121.806502 °
DWR ID	DWR_NA0021_01_f_2016_3				
Comment Code					
A3 : No rodents visible, but rodent burrows visible; need to backfill and compact or grout burrows.					
Inspector Comment

Rodent holes on levee crown. No live rodents observed. Fall inspection 10/07/2016.

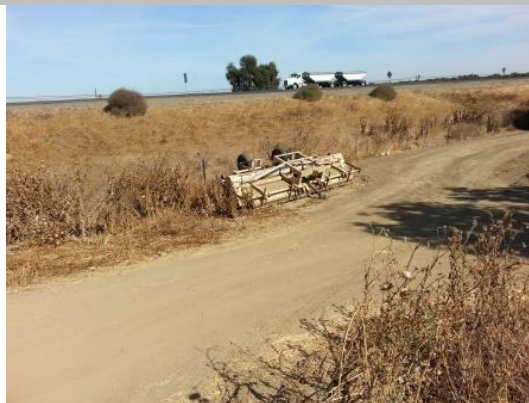
Photo 1 of 1 : SP\_2017\_NA0021\_351\_21\_20170320\_00024.jpg

LM Start	0.49	Rating **	M	Issue No.	21
LM End	0.49	Issue Type +	En	Location *	LS
Category	Earthen Levee			GPS Latitude/Longitude	
				Start	End
Item	Encroachments			38.725722 °	38.725722 °
				-121.806483 °	-121.806483 °
DWR ID	DWR_NA0021_01_f_2016_21				
Comment Code					
EQ : Equipment					
Inspector Comment

Equipment within 10-foot easement of landside toe of the levee. Fall inspection 10/07/2016.
